Recreational Water Monitoring Program

Health Services Report | 2010 - 2014

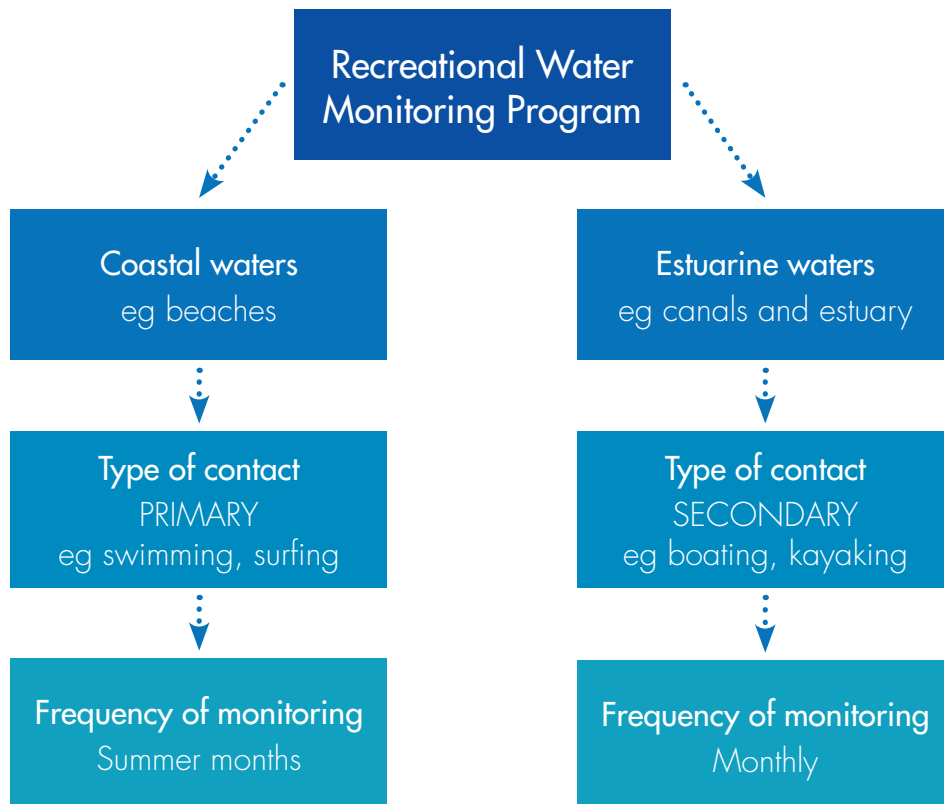
The diagram below illustrates how the recreational water monitoring program is divided into two parts.

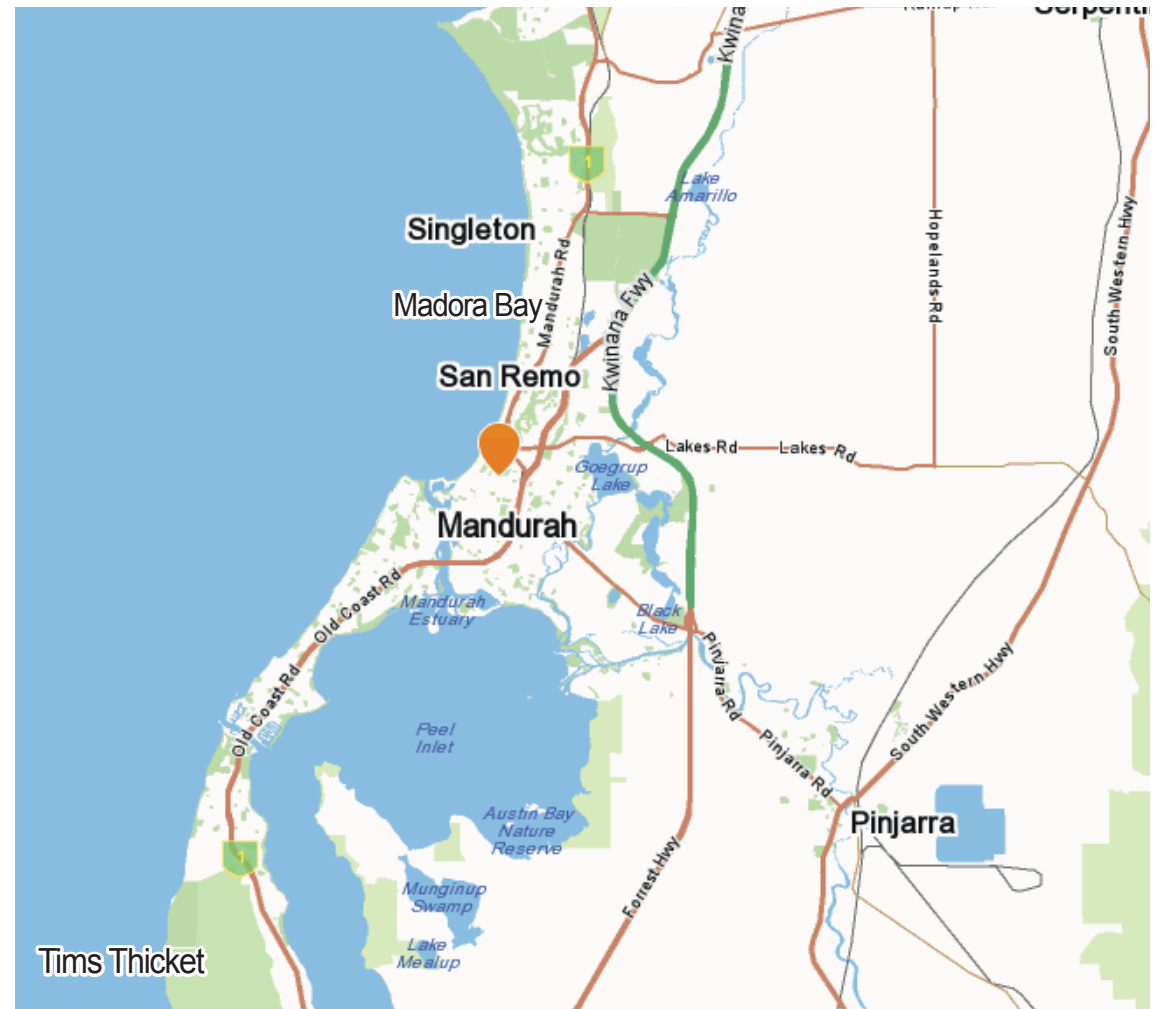
Figure 3.1 Mandurah Map showing location of Madora Bay and Tims Thicket

During the period of July 2010 to April 2014, there were 16 monitoring sites along the coastline of Mandurah, from Madora Bay to Tims Thicket; as indicated by arrows on the map in Figure 3.1.

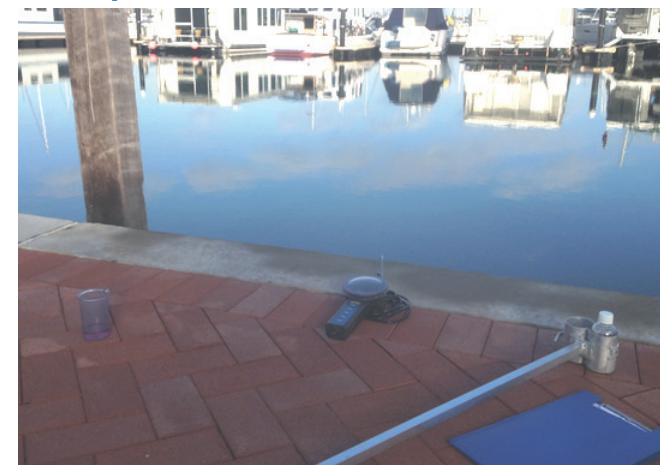
Conductivity, pH, ORP (Redox), Depth, and Turbidity). The unit measures water quality through sensor technology. A probe connected to the meter is lowered into the water column and the readings in the handheld display (see Figure 3.7) are then recorded on a sampling form.

Figure 3.7 Mandurah Ocean Marina Site: handheld water quality metre, sampling bottle and clipboard
